KENTUCKY HISTORIC RESOURCES  
INDIVIDUAL SURVEY FORM  
(KHC 2002-1)

COUNTY Lewis  
RESOURCE # Lw-59  
RELATED GROUP #       
EVALUATION S  
SHPO EVALUATION U  
DESTROYED

1. NAME OF RESOURCE (how determined): 5 / Kirkendall House

Herron Hill PSC/ Collins cell site

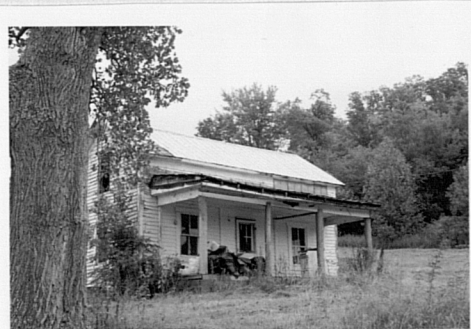
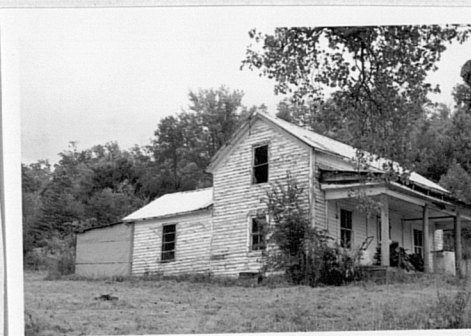
Located on Poplar Flat Road, this property is a c. 1900-1920 one-and-a-half story frame dwelling resting on a poured concrete foundation, with a side-gabled standing-seam metal roof and 2/2 double-hung sash wood windows. The front porch appears to have been added later, and rests on a concrete block foundation with tree saplings serving as supports for the shed-style standing-seam metal roof. At the rear of the dwelling are two one-story later additions. One addition is frame, with a front-gabled standing-seam metal roof and jalousie windows, and the other is a lean-to addition behind the frame addition, clad in an undetermined material. The property is owned by the Kirkendall family, and is currently vacant and in poor condition.
